# Manhole Inspection Summary

Manhole # S49K\_\_014MH

Insp Date: **3/27/08 9:19 AM**

**Location** Address: **S Glover St Lakewood**

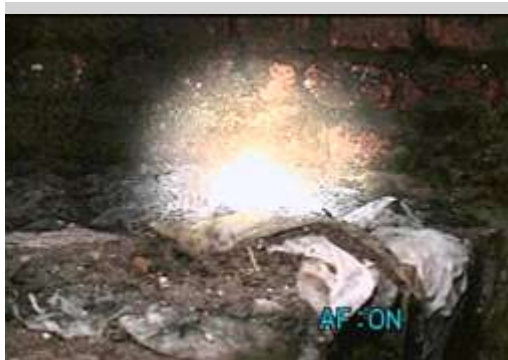
Miscellaneous

bench debris

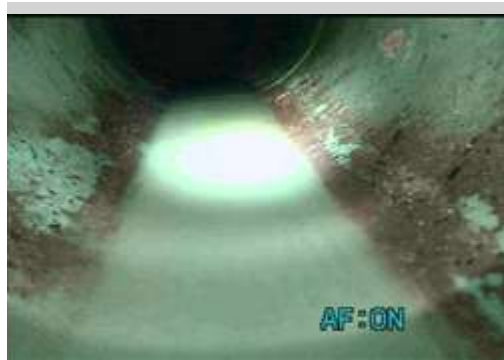
Miscellaneous

channel between 12 & 6 is pvc

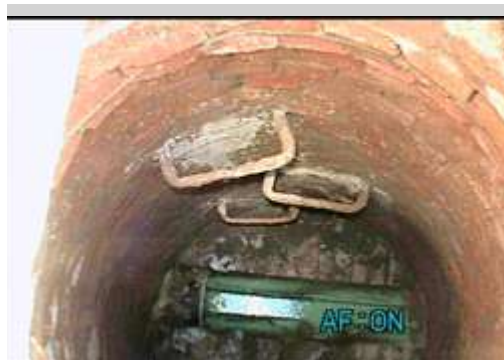
Defect 2

Count: **3** Missing: **0** ☒ **Corroded**

cor.steps

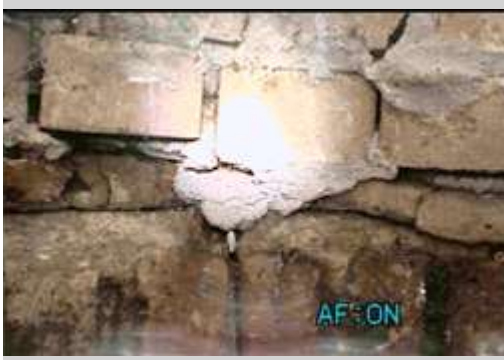
Defect 1

Condition: ☐ Sound ☒ **Cracked** ☐ Root Intrusion ☒ **Loose Brick** ☒ **Deteriorated**

frame adj cracked, loose bricks,  
deteriorated

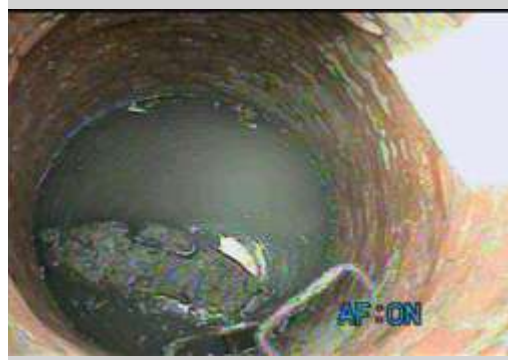
Defect 3

☒ **Evidence Of Surcharge** Depth: **3** (ft.) ☐ Active Surcharge Present

evidence of surcharge (from previous  
inspection visit)

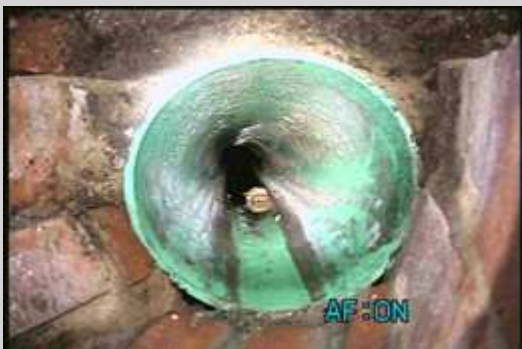
3 O'Clock Inflow

Deposits: ☐ None ☐ Mud ☐ Sludge ☒ Debris ☐ Grease

Silt Depth: 1 (in.) Deposits Extent: Light
